**Project:**  
Glacier Vista  
Plymouth, MN

**Product:**  
LondonBoulder

**Wall Design Engineer:**  
Vickery Engineering &  
Construction

**Wall Dimensions:**  
4,320 sq ft  
19 1/2 ft tall x 360 ft long

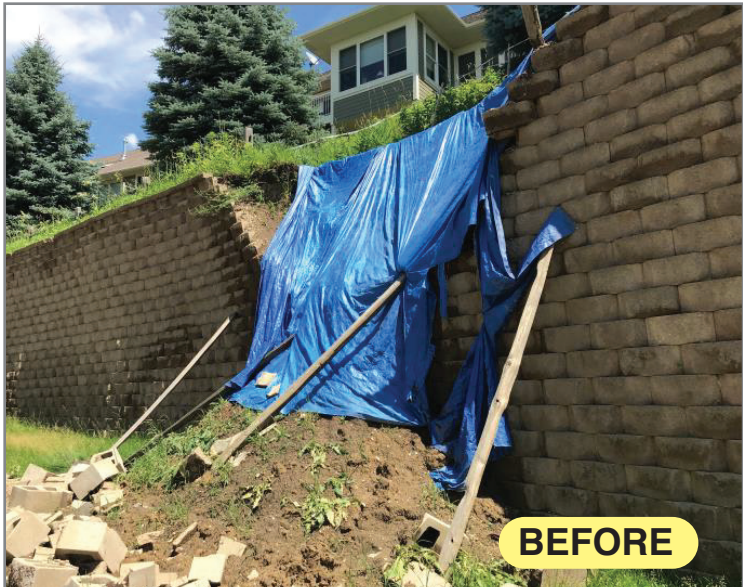
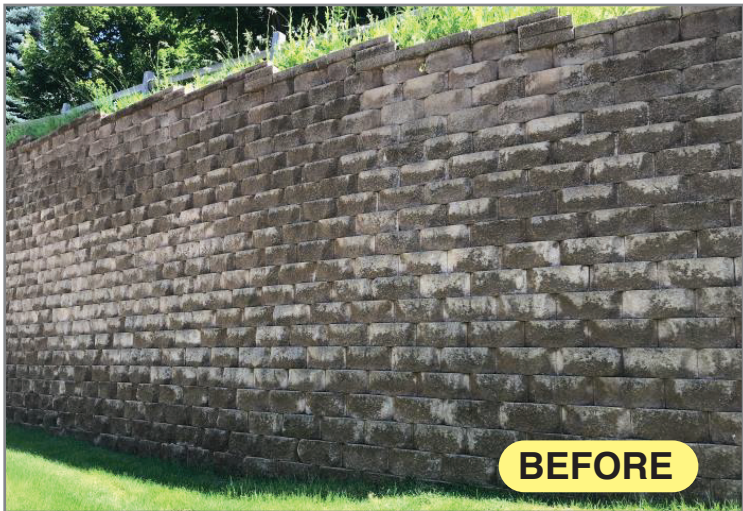
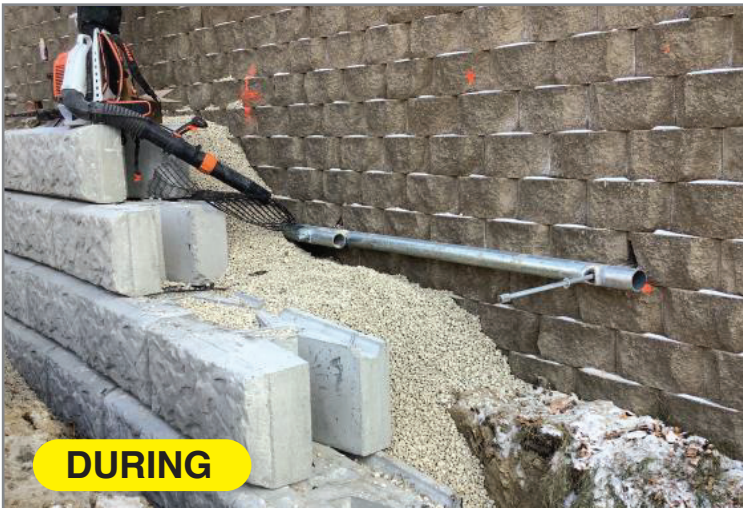
A wall failure is never desired. In 2019, a 20-foot tall small block retaining wall at the Glacier Vista development in Plymouth, Minnesota, failed. The failure was mostly caused by excess water being directed at the back of the wall, causing excess lateral earth pressure against the wall face. The major challenge to the repair was the proximity of the existing houses above the wall. Due to the wall height and the slope above the wall, excavating the existing wall and putting in a geosynthetic reinforced (geogrid) retaining wall was not possible, as it would undermine the existing house deck foundations.

The Twinhomes of Glacier Vista Association turned to Vickery Engineering and Consulting (VEC) to come up with a solution. Time was of the essence because winter was right around the corner. The method of wall repair recommended by VEC was to leave the rest of the existing wall in place and construct a new wall in front of the existing, failing, wall. After some debate with the City of Plymouth on wall location, VEC prepared a design using LondonBoulder to provide the earth retention solution needed.

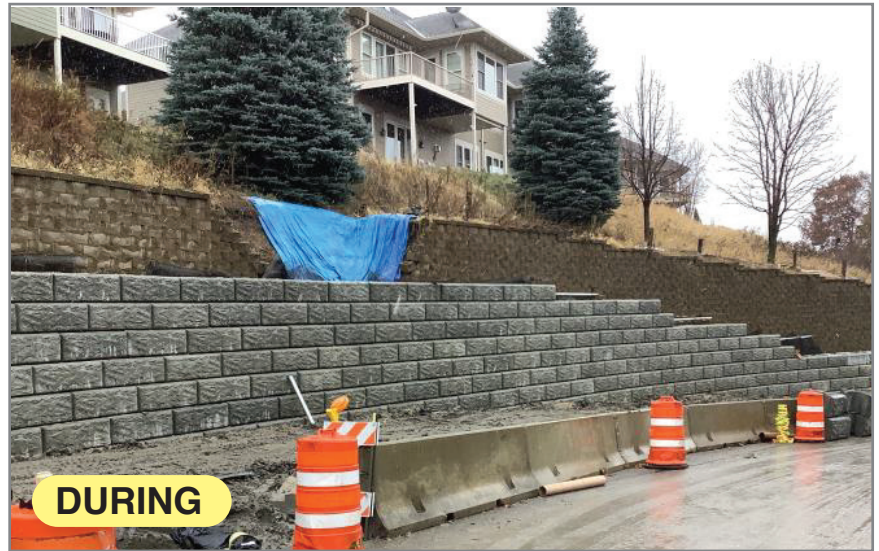
**DURING**

Manta Ray earth anchors were driven through the existing wall and, with the use of horizontal pipes and geogrid to attach the wall face, a new LondonBoulder wall was constructed in front of the existing wall. LondonBoulder was chosen because of the durability and the speediness of placement of the block. Precision Hardscapes of Braham, Minnesota did the construction in November of 2019, and within several weeks, the new wall was in place, and final grading was performed right before the first snow fell. Through the rapidity and ease of the installation of the LondonBoulder units, the new wall will provide stability to the slope and peace of mind to the residents for years to come.
